# Alur Ilmu

## Perihal

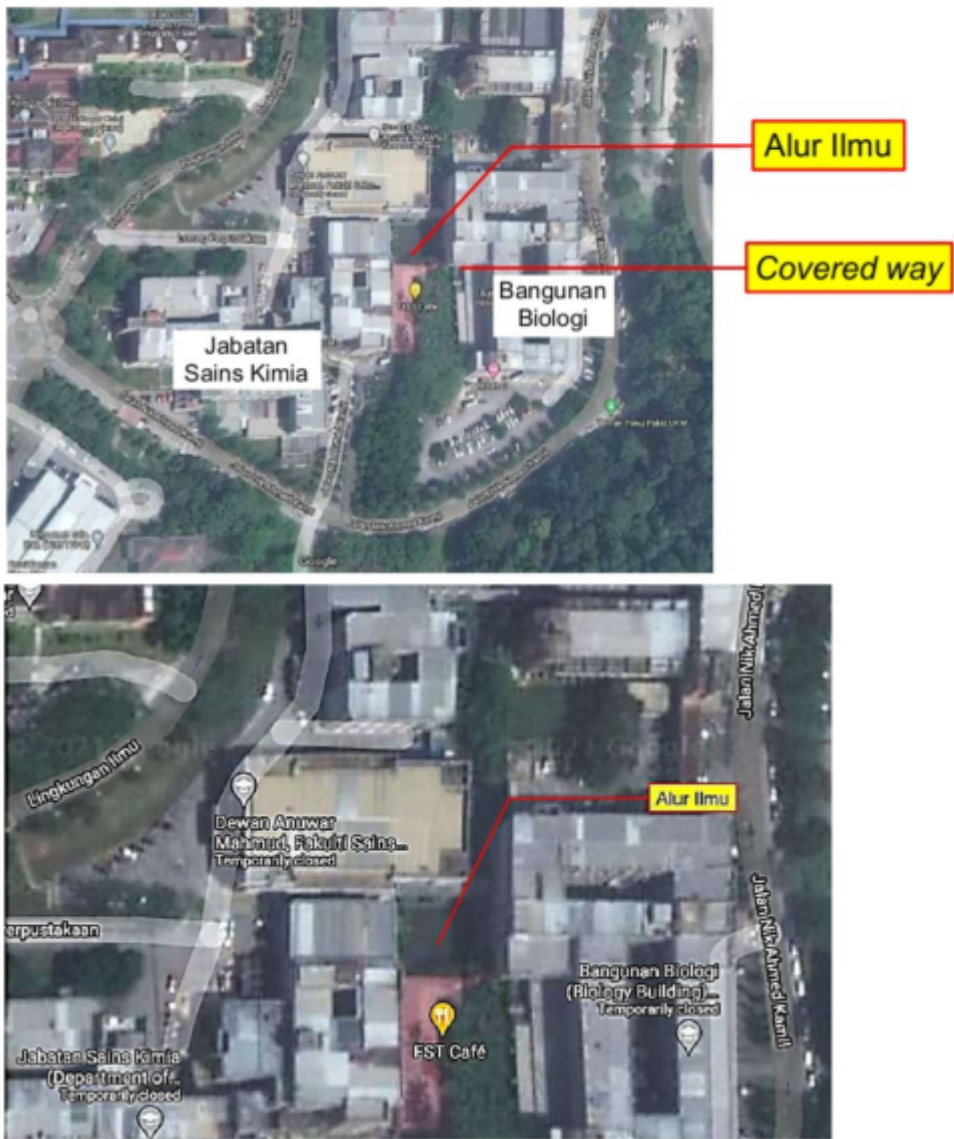
| RAJAH | LOKASI / ARAS | KOMPONEN | KECACATAN / KEROSAKAN | KETERANGAN |
|---|---|---|---|---|
| Kiri | Koridor (032), Pejabat Pengurusan Paku Pakis (034) dan Covered Way / Tingkat bawah | Dinding dan siling | Kulat hijau dikesan pada sebahagian besar dinding koridor. Bingkai siling mempunyai kesan berkemungkinan hasil daripada tindak balas kimia. Pemilihan bahan untuk kemasan siling tidak bersesuaian dan perlu ditukarganti dan diperincikan semula mengikut standard dan spesifikasi yang tepat. | Kulat mungkin merebak disebabkan oleh kelembapan persekitaran yang tinggi kerana berhampiran laluan aliran air (Alur Ilmu) yang melalui bangunan. Pengudaraan yang kurang baik mungkin penyumbang kepada masalah kulat. |

| RAJAH | LOKASI / ARAS | KOMPONEN | KECACATAN / KEROSAKAN | KETERANGAN |
|---|---|---|---|---|
| Kanan | Aras Bawah dan "tunnel" | Dinding, siling dan lantai | Kulat kelembapan | Hampir keseluruhan kawasan (dinding, siling dan lantai) di kawasan "tunnel" dan ruang berhampirannya berkulat teruk. "Tunnel" sentiasa menakung air kotor daripada pelbagai sumber seperti banjir, kebocoran paip dan sebagainya. Melalui temubual, wakil UKM memaklumkan bahawa, sistem saliran air sedia ada masuk ke dalam bangunan, manakala pam yang ada tidak berfungsi. Paras air yang bertakung dalam bangunan mencecah sehingga ke paras lutut. Selain itu, air juga masuk dari pelbagai sumber seperti hujan, "tunnel", tasik dan lain-lain. Apabila aliran air yang dikenali sebagai "alur ilmu" (tasik berhampiran bangunan kimia) melimpah, airnya dikatakan pernah memasuki ke ruang bawah bangunan. Air juga keluar daripada tepi (kiri kanan tanah). Kulat yang terjadi di kawasan "tunnel" mungkin merupakan salah satu punca utama bermulanya perebakan kulat di bangunan ini. |

Laporan forensik JKR pada Ogos 2021 mengenalpasti antara faktor utama masalah kulat yang dikesan pada beberapa bangunan di UKM ialah aliran Alur Ilmu di situ.
